Technical Evaluation of the Gold King Mine Incident

San Juan County, Colorado

U.S. Department of the Interior
Bureau of Reclamation
Technical Service Center
Denver, Colorado

October 2015

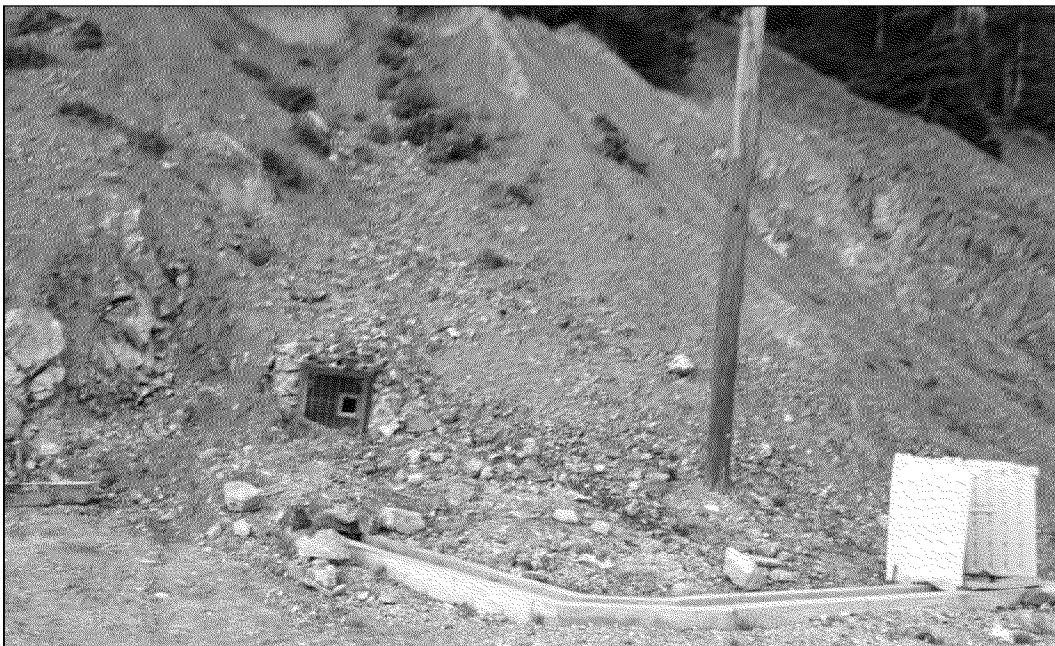
Figure 22.—Photograph showing the condition of the Gold King Level 7 New Adit portal on August 27, 2014, prior to any EPA modifications. Soil and rock debris have migrated downslope and covered a portion of the drain installed in 2009 (photograph from EPA project files).

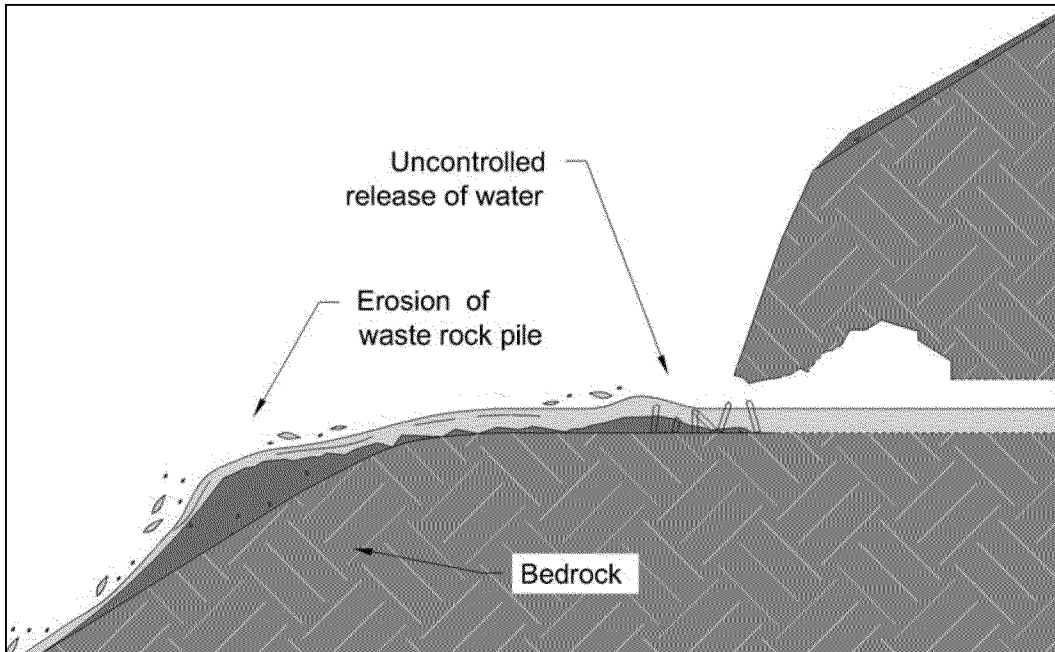
Figure 55.—Cross-section showing the blowout as it eroded the blockage and eroded fill from the waste-rock dump (not to scale).
